# RESTORATION OF SMALL RIVER TO INCREASE THE RECREATIONAL AND TOURIST POTENTIAL OF RURAL AREA

**Andrej Škrinár, Michaela Danáčová, Roman Výleta**

*Department of Land and Water Resources Management, Faculty of Civil Engineering, the Slovak University of Technology in Bratislava, Radlinského 11, 810 05 Bratislava, Slovakia*

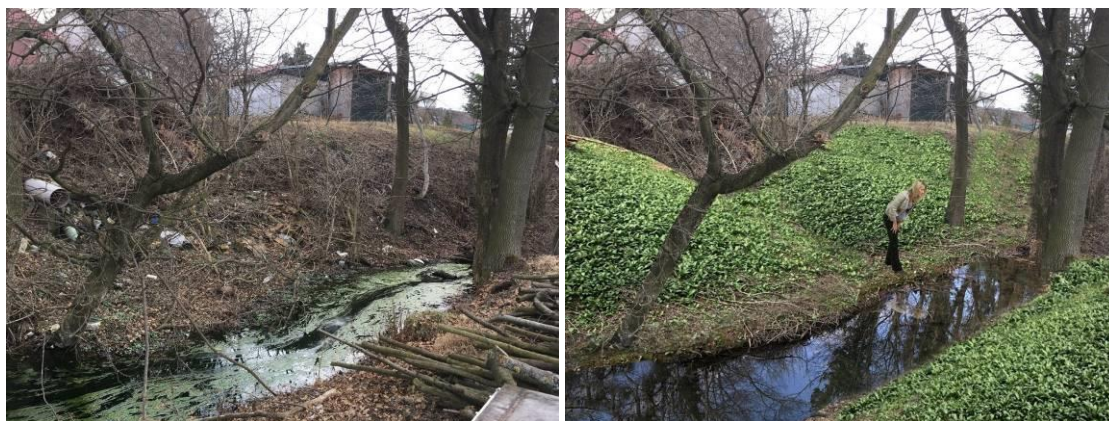
Fig. 3: Waste dumps with eutrophicated millrace and rendering of the design

To increase the channel variability of the regulated stream, the best step is to recreate the original meanders along with implementing changes in the longitudinal profile. In this locality, there is an old unused millrace, which is in poor condition, full of waste material and heavily eutrophicated (Fig. 3). By its restoration and connection to the regulated main riverbed a side arm will be created (Fig. 2, Fig. 4) and a valuable variable microhabitat will be obtained in the aquatic environment as a counterweight to the monotonous regulated reach.

The area around the millrace is currently in very poor condition and serves local citizens as a waste dump and septic (Fig. 3), where sewage is discharged from individual houses. Waste dump removal together with the construction of a sewage network or responsible individual sewage management is a prerequisite for the successful restoration of Teplica and the millrace. The connection of the millrace will be the first step towards the revitalization of the whole area, where the flowing water is expected to bring life to the locality and the measures were designed to use the flow potential for aesthetic formation of public space and increase the attractiveness of the area for recreation and tourism development.

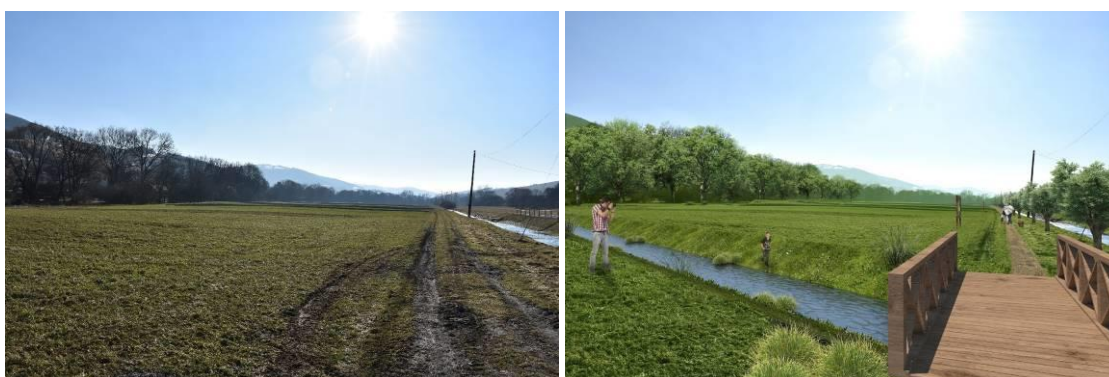
Fig. 4: Current state of the area and rendering of the connection design

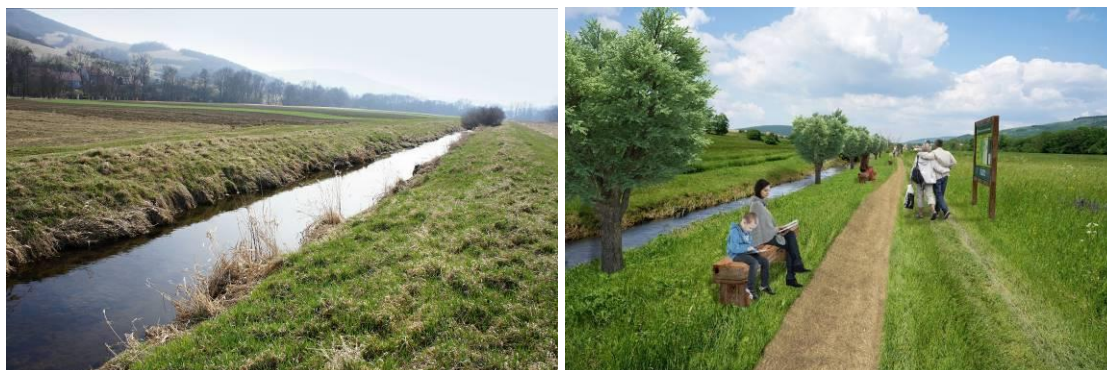
Fig. 5: Current state of Teplica and proposal of the riparian vegetation

Riparian vegetation by autochthonous tree species (Fig. 5) was also proposed to create a local greenery along the river.
