UTILIZATION OF GOOD PRACTICE OF TORRENT CONTROL IN RECREATIONAL EDUCATION IN THE VEĽKÁ FATRA NATIONAL PARK

In the article we present the possibility of using an example of good practice of torrent control in recreational and leisure education of the public and university students. For this purpose, we chose the torrent control Jelenec in the Hornojelenecká valley in the Veľká Fatra National Park. Hornojelenecká valley is one of the most beautiful and most visited recreational locations in the Veľká Fatra National Park. This valley forms a natural watershed of the Jelenec torrent with a historical torrent control, which was established in 1926-27 and has reliably fulfilled its function for 95 years. Based on field measurements, we analyzed the runoff characteristics of the watershed and the discharge characteristics of the torrent in an effort to present the results of research in recreational tourism and university education. The main goal is to raise awareness among the general public about the importance of integrated forestry measures to protect the landscape from flash floods and erosion in recreational education. We evaluated the capacities of flow profiles in relation to T-y

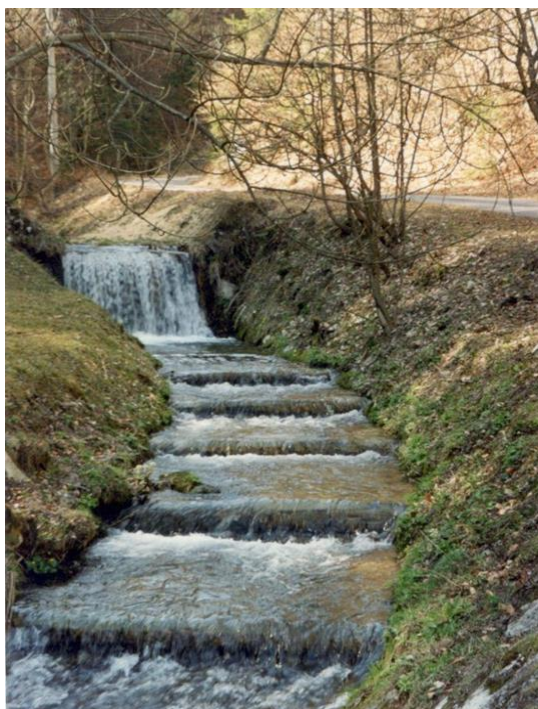
Fig. 2: Weir and sills in Jelenec torrent in the immediate vicinity of the hiking trail

vast majority of the length of the Jelenec torrent control (3.33 km) is sufficient for a discharge of Q_{100} . Roughly marked data in Tab. 3 means T-year discharges, which safely flows through the flow profile (section). In some sections, the capacity of the flow profiles ranges from Q_5 to Q_{50} . In these sections, on the information boards we propose to increase the capacity of the flow profile through longitudinal reinforcement of the bed with a lower roughness (smooth wood, stone), possibly we suggest increasing the total flow profile area through natural stone wall. At the same time, we designed information boards for transverse objects along the torrent control Jelenec (belts, sills, weirs, dams) with an explanation of their construction elements and meaning.

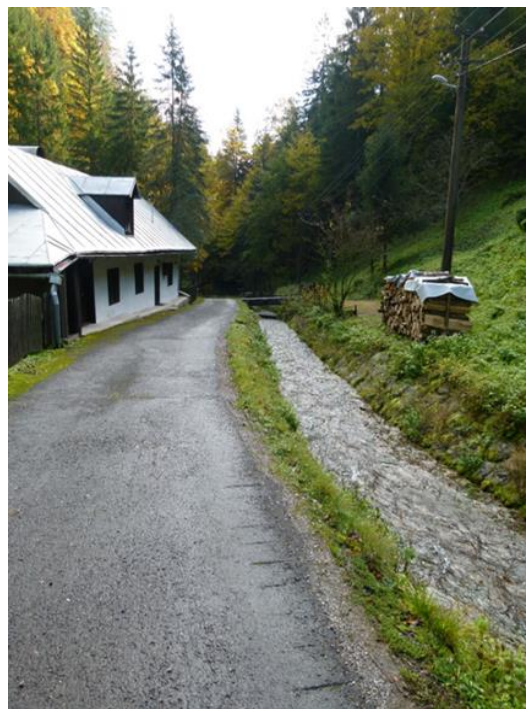
Fig. 3: Reinforced bed of Jelenec torrent in the immediate vicinity of recreational path
