RECREATIONAL POTENTIAL OF NEWLY BUILT POOLS

Abstract

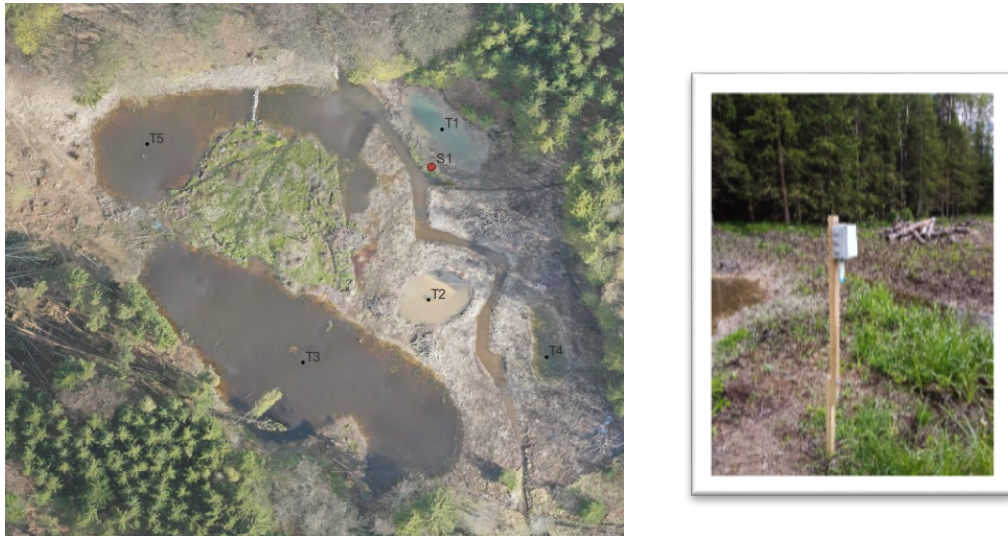
A sensor was installed at the site in May 2022 to continuously monitor local air temperature and humidity. (Fig. 2)

Fig. 2: View of site 4/2022, sensor located near pool T1 point S1

In April 2022, the site was flown by drone and a digital terrain model was created.

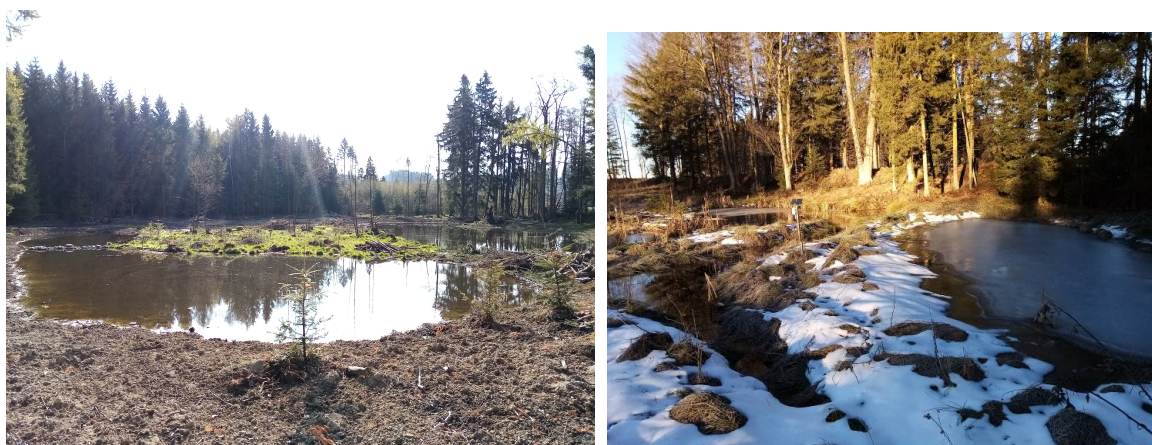
Fig. 3, 4: Photo of the area 6/22 (Pelikán 2022); 12/23 (Marková 2023)

It was already evident in the first growing season that the site would soon become a habitat for aquatic and wetland species after completion of earthworks. The photo documentation shows the progressive development of aquatic and riparian vegetation. Water-bound insects and small animals were recorded during visits/sampling.

By the beginning of the second growing season, the involvement of the pools in the surrounding area is already visible, with the presence of a diverse range of aquatic and wetland plants such as common cattail (*Typha latifolia*).

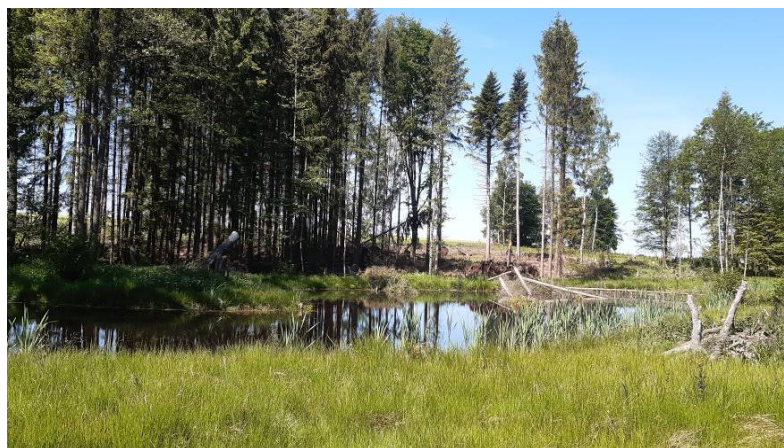
Fig. 5: Photo of the area 5/23 (Marková 2023)

In the third growing season, seedlings of alder trees that have been cut down begin to appear on the site, except for a no-intervention zone with coppice alders in the centre of the area. Natural alder regeneration is evident here.
