# THE BLATNÁ WATER DITCH – AN EXAMPLE OF CONNECTING MULTIPLE INTERESTS WHILE PRESERVING A FUNCTIONAL MONUMENT OF TECHNICAL HERITAGE

**Miloš Rozkošný<sup>1</sup>, Miriam Dzuráková<sup>1</sup>, David Honek<sup>1</sup>, Jaromír Florian<sup>2</sup>, Aleš Vyskočil<sup>2</sup>, Kateřina Sedláčková<sup>1</sup>, Zbyněk Sviták<sup>2</sup>**

## Abstract

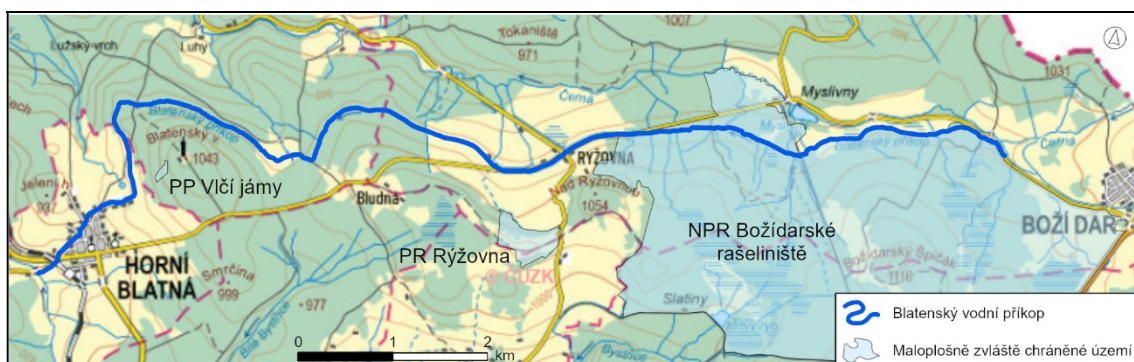
Fig. 1: The Blatná water ditch route

According to written sources, the Blatná water ditch was built at the turn of the 1540s by a person called Stephan Lenk, not long after the discovery of tin deposits in the vicinity of Blatenský hill and the subsequent foundation of the town of Horní Blatná (1532). An almost 12 km-long water ditch with an average slope of 3 ‰ was started to the west of Boží Dar, where it took water from Černá Brook, from where it led through Myslivny, Ryžovna, Bludná, along the northern slope of Blatenský Hill to Horní Blatná (Fig. 1), where its water provided the propulsion power for the equipment and machinery in mining and processing operations (the crushing and smelting plant of extracted tin ore) situated to the west of the core of the town buildings. To the south of the town the ditch led into the Blatenský Brook. From the early 1870s, the Blatná water ditch operated under the name of a newly formed water cooperative based in Horní Blatná. The water ditch served its function and was maintained till the displacement of the local German population after the Second World War. Then it lay decaying for half a century (Cais, 2018).

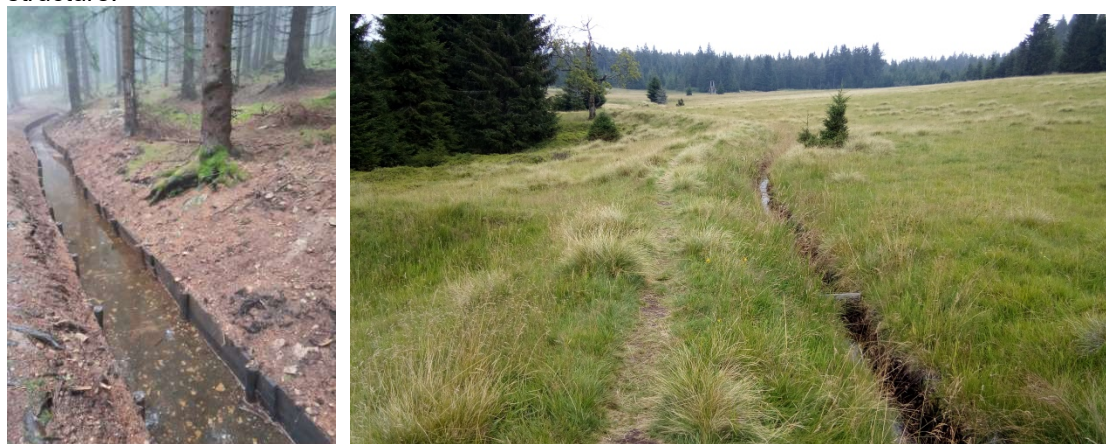
The water ditch is about 2 metres wide and over 1 metre deep (Fig. 2). Its trough was reinforced with wooden battens or lined with stone cladding and in the past it was covered year round. The whole works was equipped with necessary technical elements which ensured the desired function. It involved: (i) a system of sluice gates; (ii) supply and drainage branch channels; (iii) traps for gravel and sand deposits drifted by the current of tributaries which supplied water to the ditch; (iv) overflows which, on the contrary, served to drain an excessive amount of water from it into the Černá River; (v) culverts under roads; (vi) bridges over the ditch or water transfer (via aqueduct) allowing crossing the brook. They could be used to carry out regular walking inspections of the ditch (nowadays they are often used by tourists), check its flow rate and remove any obstacles or repair damage to the structure.

Fig. 2: Channel of the ditch in a forest area (left) and in an open landscape (right)
