# Recultivation after the Peat Mining at Branský les I.

*The contribution describes a recultivation process after peat harvesting in the Bransky Les I. location. The recultivation of peat bogs is one way to increase the volume of water in nature. This practical experience shows how complicated it is to achieve this goal. Harvesting of peat was finished in 2018. The process of recultivation was started in 2019 and finished at the end of 2020. Nowadays, in 2024, the locality was visited to see what has happened in the last six years after the end of harvesting.*

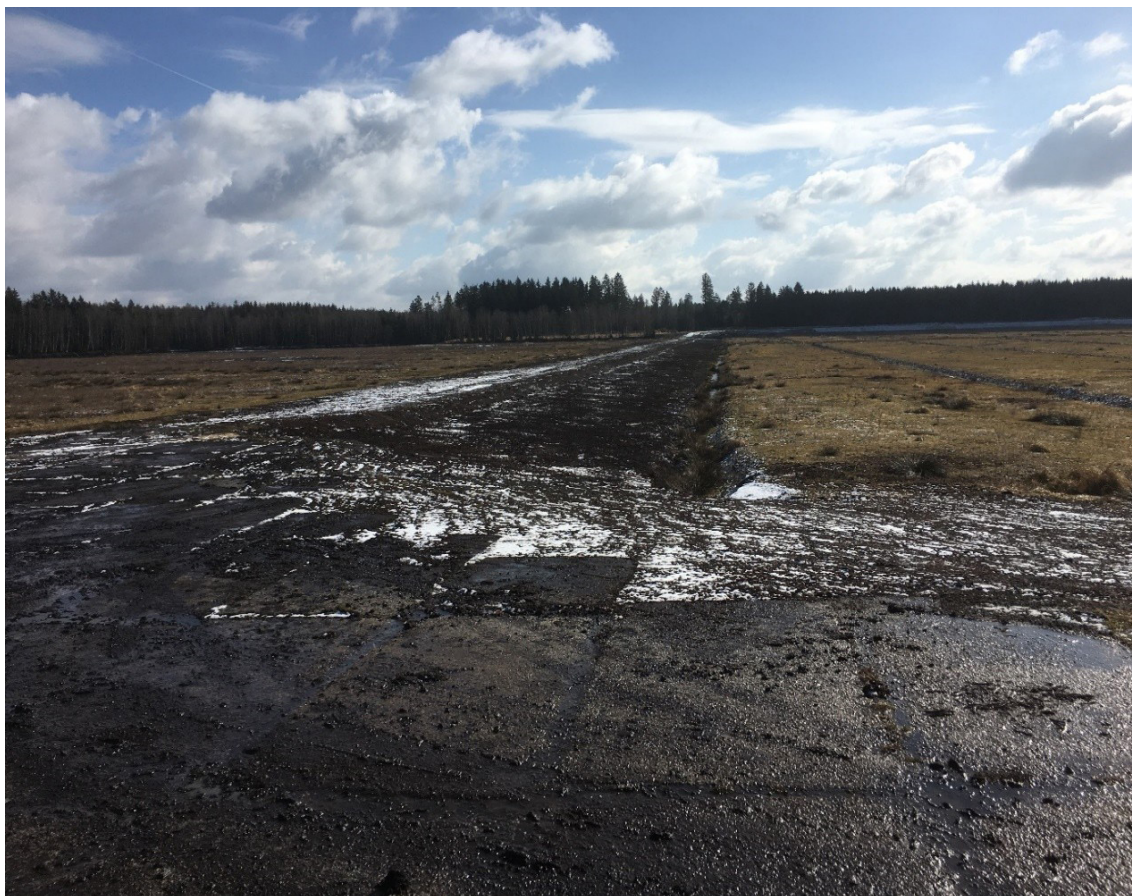
**Fig. 1:** Part of the site set aside for forest reclamation on the right of the road. A section set aside to create a „peat ecosystem“ to the left of the road. March 2021.

According to the reclamation plan created at the request of the owners, about 55 ha were handed over in a state ready for reforestation, and about 10 ha were left ready for the creation of a “peat ecosystem” (the area north of the road crossing the mine area). In accordance with the recultivation plan, the wishes of the owners and concerned state authorities (apart from the AOPK CR), there was no significant interference with the locality’s water regime, which means there was no damming of the main drainage channel and no rise in the groundwater level. In the area designated for the creation of a „peat ecosystem,” side channels were disabled by including a five-meter section in the connection area to the main drainage channel. Eight pools with a size of approx. 400 m<sup>2</sup> were built on the territory, in the places of the original drainage channels. The areas were beginning to become massively overgrown with sedge (*Scirpus sylvaticus* L.), common dogwood (*Agrostis capillaris* L.), bush reed (*Calamagrostis epigejos* (L.) Roth), red nettle (*Juncus effusus* L.), red wormwood (*Persicaria maculosa* Gray), with the occasional occurrence of hedgehog (*Echinochloa crus-galli* (L.) P.Beauv.). Small birch saplings appeared here and there. The owners assumed that the territory would be left to spontaneous succession with a possible subsequent network or planting, while fulfilling legislative obligations.

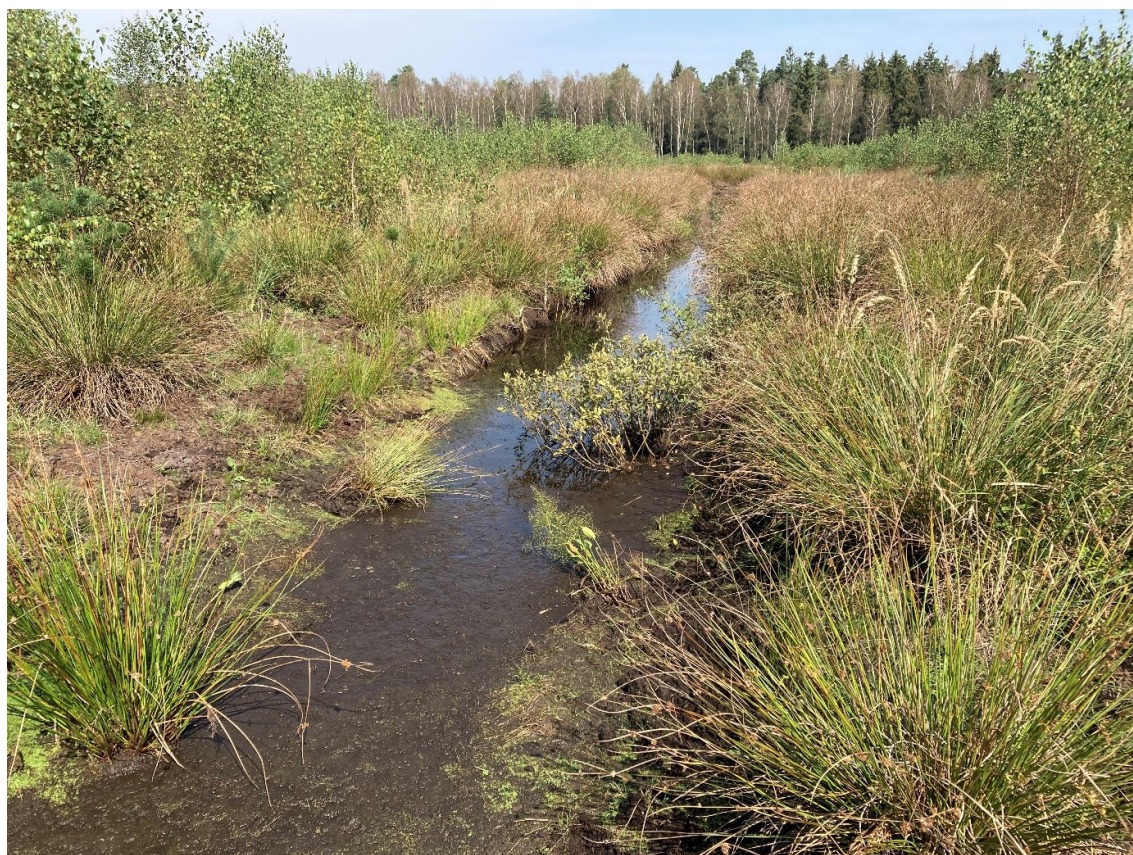
**Fig. 2:** A section set aside to create a „peat ecosystem“ September 2024.

The state of the locality in 2024. The territory has been left to spontaneous succession. The areas are overgrown with birch. Scots pine (*Pinus sylvestris* L.) is rarely found. In higher places, especially on the edges of the area, different types of willows are starting to appear, specifically the eared willow (*Salix aurita* L.) and the ash willow (*Salix cinerea* L.). The herbaceous layer is dominated by common dogwood (*Agrostis capillaris* L.), bush reed (*Calamagrostis epigejos* L.) and decomposing nettle (*Juncus effusus* L.). St. John's wort, St. John's wort (*Hypericum perforatum* L.) and spotted St. John's wort (*Hypericum maculatum* Crantz) are found in places. Here and there the reed-like scab (*Phalaris arundinacea* L.) appears. The red worm (*Persicaria maculosa* Gray) has almost disappeared. Pool starfish (*Callitriche stagnalis* Scop.) grows in the canals. The green grasshopper (*Pelophylax esculentus* L.) is abundant in the canals. A green layer covered most of the previously mined areas. The difference between the „peat ecosystem“ and the rest of the land can be seen in the greater concentration of decomposing nets around the side channels, which are different from the side channels in the water-filled “forest” part. However, the ground water level is also lowered here so that the peat on the surface is too dry in the summer and moisture on the surface is dependent on water coming from precipitation. Although optimal conditions have not been created for the restoration of the wetland, and probably not even the forest, here too nature shows that it can eventually take care of itself.
