## THE HIPOROUTES IMPLEMENTATION OPTIONS FROM ALTERNATIVE MATERIALS

### Abstract

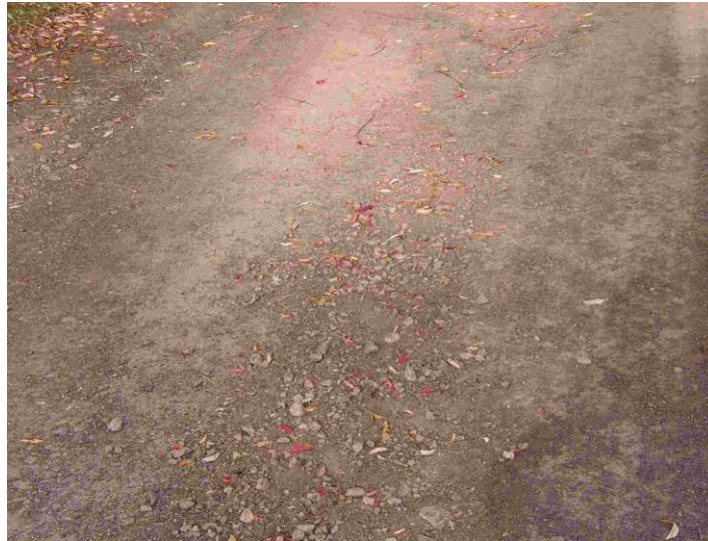
Within the test section, four sub-sections with different components were implemented and mixed into the milled aggregate layer of the existing roadway to a depth of 0.2 m (Fig. 1).

Fig. 1: Detailed view of the modified road cover.

On the first section, a mixture of 3.5% cement and 3.5% coarser rubber granulate was chosen. On the second section, a mixture of 3.5% cement, 3.5% asphalt emulsion and 3.5% fine-grained rubber granulate was chosen. For the third section, a mixture of 3.5% cement and 3.5% asphalt emulsion was used. For the fourth section, 3.5% cement was used.

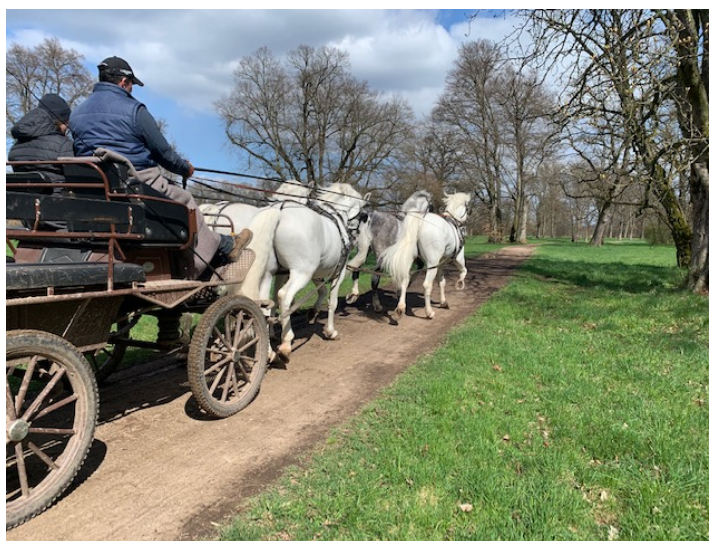
The aim of the long-term monitoring of the layer in the test section was to answer whether the stabilised layer's properties do not change due to use and climatic conditions. The selection of appropriate field tests had to consider the technological possibilities and the difficulties of working in the conservation area (UNESCO site, work in operation). For the basic field test on the stabilised layer, the impact load test referred to as the light dynamic plate (hereinafter abbreviated as LDD) was selected in accordance with CSN 73 6192. The LDD measurements were carried out in the third and fourth test sections under 17 years of traffic, at a stationing interval of 50 m alternately in the left and then in the right wheeltrack, for the reason that in these parts of the roadway, the traffic loading was most significant. At the Kladruby National Stud Farm, carriage horses are trained in multi-passage, with horses moving side by side on the road and the traction of the carriage wheels is also carried out in two tracks of approximately 0,50 m width (Fig. 2).

Fig. 2: View of the quad training on the test section after 17 years of operation.

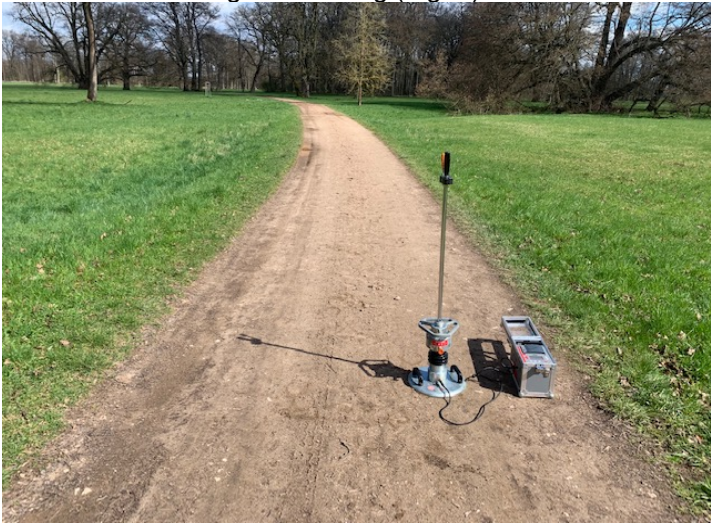
The measurements were performed with a lightweight dynamic plate ZFG 3000 GPS with a diameter of measuring plate of 300 mm and a weight of 10.0 kg (Fig. 3).

Fig. 3: View of the impact load test measurements on the pavement surface.

Before the actual measurement, the preparation for the measurement consisted in placing the load plate on the desired location and moving and rotating it to a horizontal position, followed by connecting the load plate to the measuring device with a measuring cable and loading the tested area with three preliminary shocks, followed by the actual measurement and finding the position of the measured point using GPS coordinates.
